P1394a meeting minutes July 30, 1996 San Jose CA

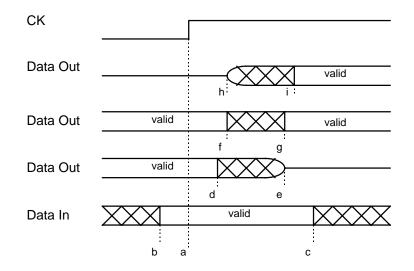
In an attempt to improve table J-22, Bill Duckwall drew a timing diagram to illustrate the timing parameters that should be defined in the table. This applies equally to LREQ, DATA, and CONTROL signals.

The table in the standard should contain correct numbers in each place that nnn occurs in the above table. As noted above, manufacturers of Link and Phy chips need to discuss what the numbers should be to insure interoperability between different manufacturer's chips. We need to consider what conditions need to be specified.
